UNLOAD CIRCUITRY

MAIN BOARD

Reported ram problem, CPU #1

BFIB problem:

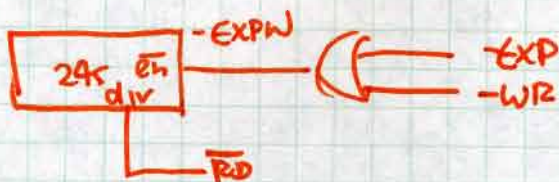
WAS

Discovered logic error on 245, prevented reading external I/O space.

Base7 is recommended for future designs.

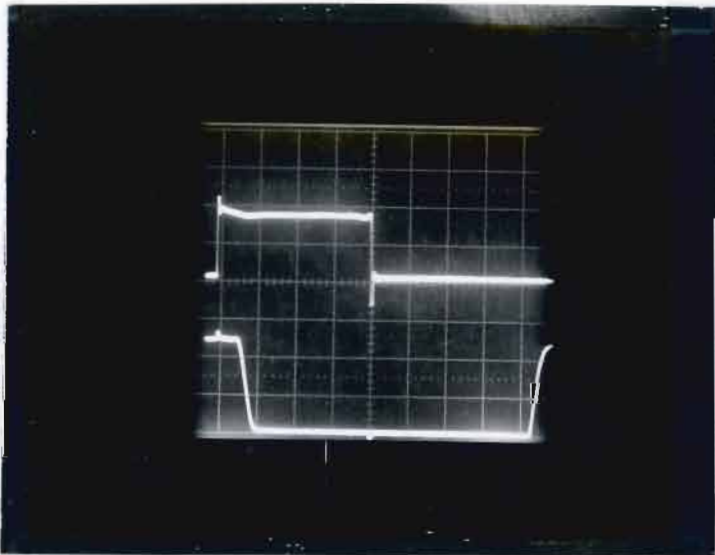
2V/div vert
200ns/div horiz
Traces are zeroed
at center and
bottom.

Zero overlap.

TB No glitch, but signal wiggles a bit.

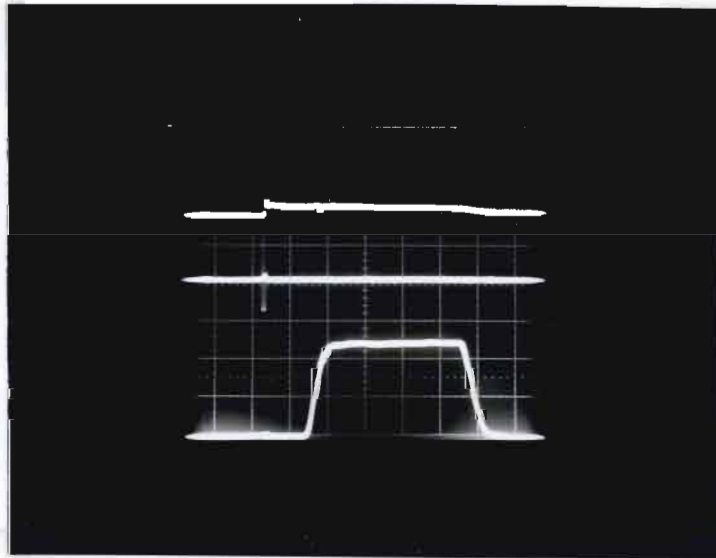
150-225 ns setup time change.

CMOS takes 75ns longer than LS TTL.

Only change 74C941 for 74LS244!

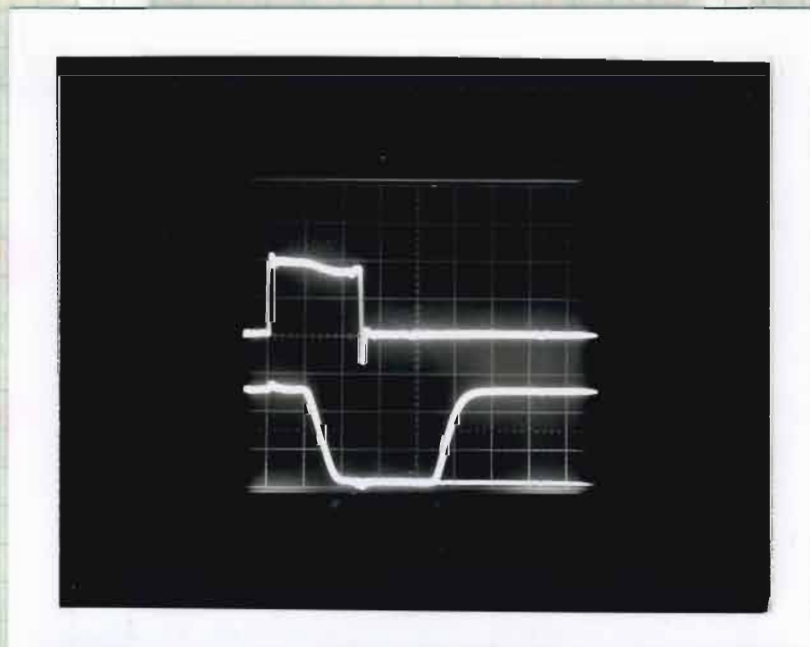
2v/div vert
(centered)

Note significant overlap.

No glitch.

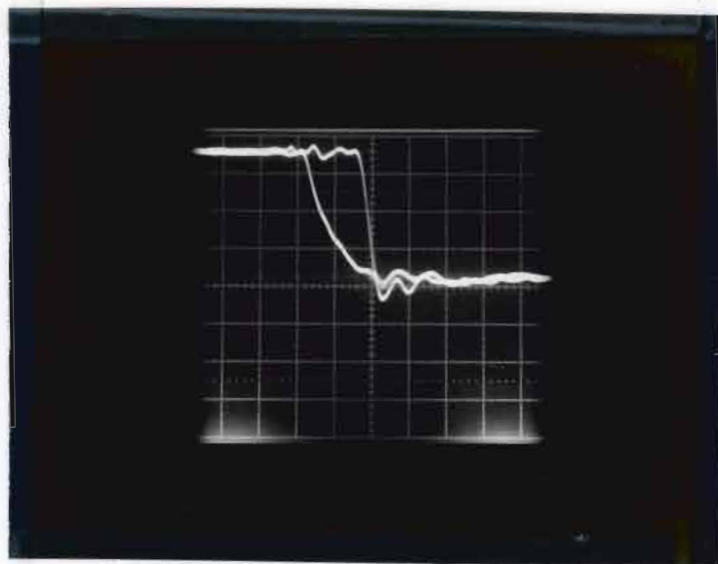
Analysis: With a 74LS00 the -RAS line is overloaded and the H \rightarrow L transition is slow, irregular and delayed. With a 7400 it is better, 74H00 better yet. 74500 rings alot, but probably due to scope.

\overline{RAS} & \overline{CAS} 20ns/div 1v/div

-RAS driver: 74LS00

Suggestions: Use 74S373 for the RAS address driver.

Use ~~7400~~ 74H00 (or 74500 if the signal quality can be verified). This fixes the H \rightarrow L -RAS transition.

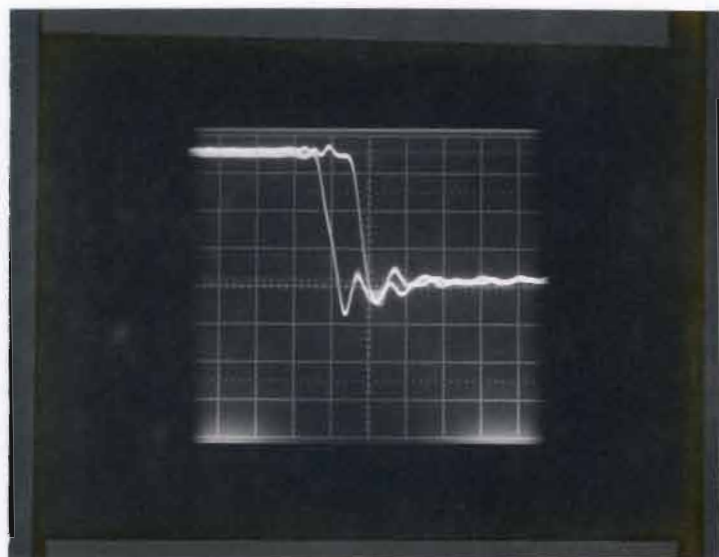
Flokey board has power supply voltage of 4.75v.

\overline{RAC} & \overline{CAE} 20ns/div 1v/div
using 74H06, 745373, 4.74 V supply

Use supply voltage = 5v.

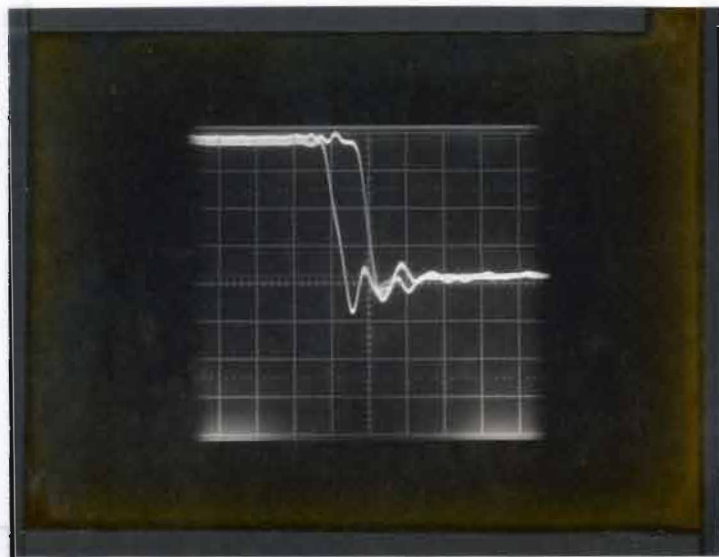
\overline{RAS} & \overline{CAS} 20ns/div 1v/div
using 74H06, 745373, 5.00 V supply

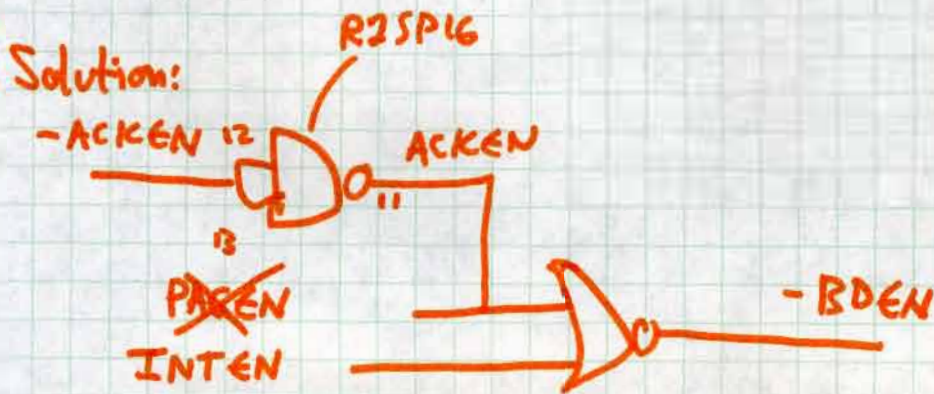
BFIB board screws up ram accesses
to addresses XFFx .

Problem: incorrect logic on BFIB board: output
drivers gated with I/O address without
I/O access:

Added to BFIB to make BFIB2. Board changed.
Untested.
